LATROBE RESERVOIR

PHASE I INSPECTION REPORT.

6 NATIONAL DAM INSPECTION PROGRAM. ✓

PHASE I INSPECTION REPORT
NATIONAL DAM INSPECTION PROGRAM
LATROBE RESERVOIR
NDI# PA-479, PENNDER# 65-66

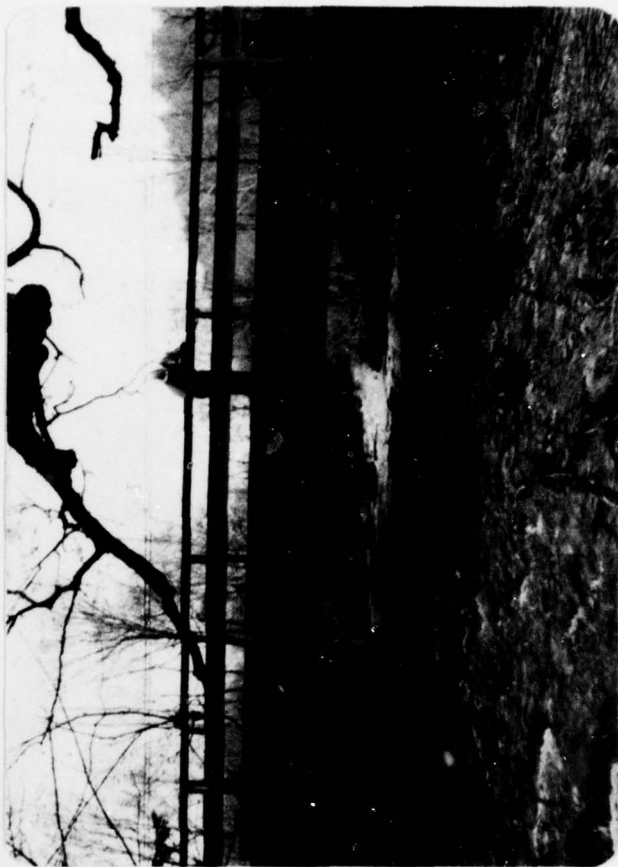
PHOTOGRAPH 8 View of a two-lane bridge located approximately one-half mile downstream of the embankment. It represents the first restriction downstream.

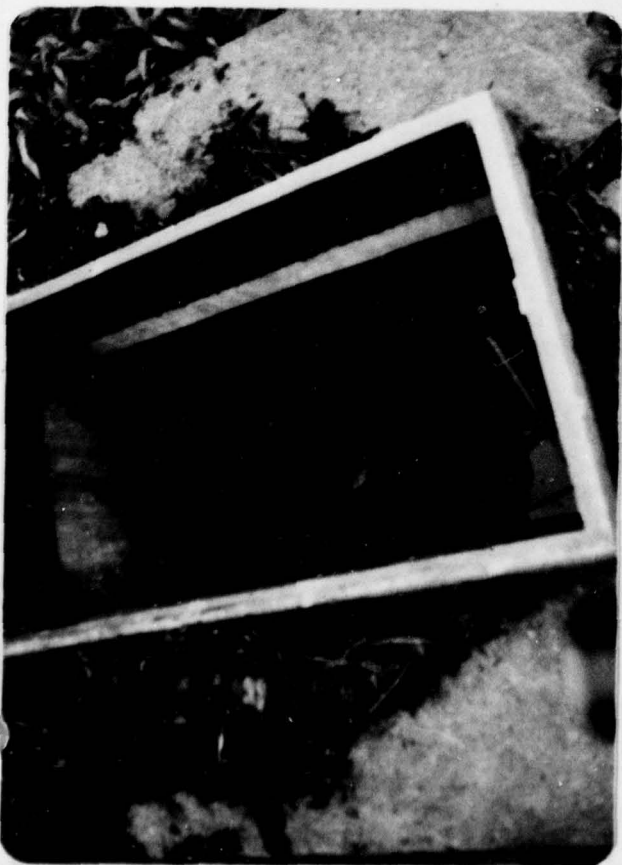
b) 24-Inch Supply Pipe. A 24-inch cast iron supply pipe, encased in concrete within the new structure, passes beneath the dam to a point a few hundred feet downstream. A valve box is located at this point which serves to utilize the supply line as a blow-off pipe enabling the water authority to discharge water into the downstream drainage system (see Photograph 5).

2. Gate House, Valves, and Supply Line. Access to the gate house is by boat, which was not available during our inspection, consequently, we were not able to assess condition of the mechanical systems within the gate house. According to a representative of the Water Authority the system is in good working order. The downstream gate valve which regulates flow from the supply line to a 24-inch blow-off line was observed (see Photograph 5). The valve is located in a concrete pit approximately 250 feet downstream of the dam. The valve was greased and appeared in good order.

PHOTOGRAPH 5 View of the valve on the 24-inch blow-off pipe located approximately 250 feet downstream of the center of the embankment.
